**Test report no.:** 127028/17-III

**Order:** Determination of resistance to root damage to flexible sheets and coatings for roof planting according to FLL (2008) on the flexible sheet "Alkorplan L 35177" nominal thickness 2.0 mm

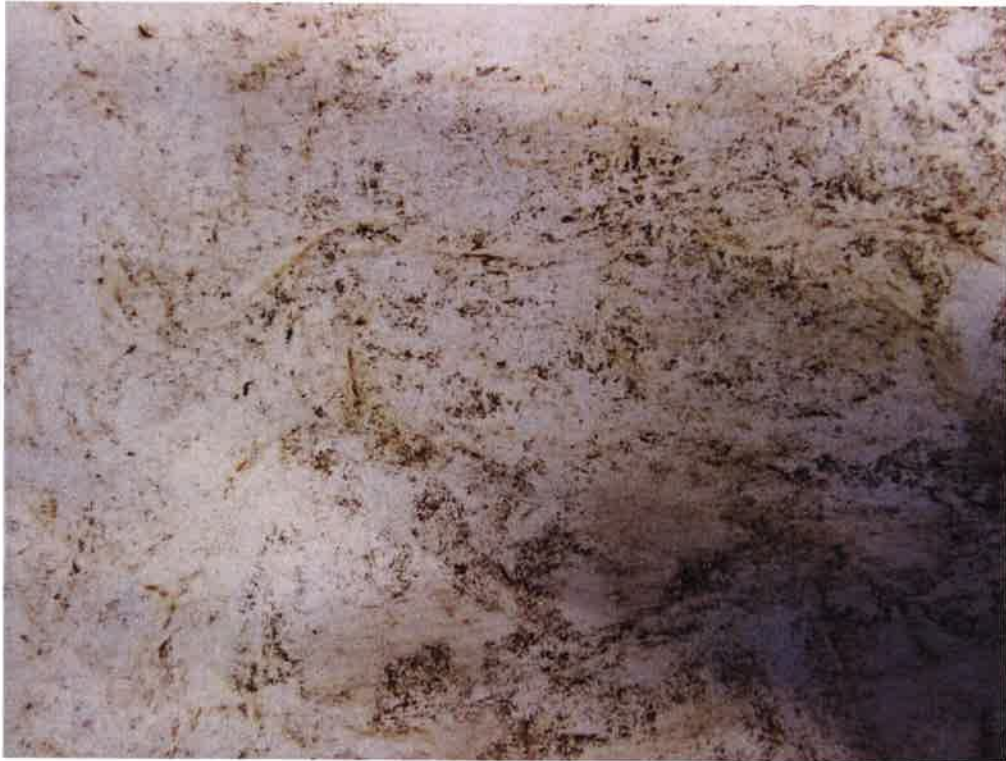
Figure 1: Membrane surface

At the end of the test period (December 2019) the containers were emptied for a detailed check of the membrane "Alkorplan L 35177" for root or rhizome penetration and perforation. The surface and the joints of the tested membrane did not show any perforations or penetrations caused by roots and rhizomes, see figure 1 – 3.
